ALEXANDRIA: KOM EL-DIKKA EXCAVATIONS AND PRESERVATION WORK PRELIMINARY REPORT 2007/2008

Grzegorz Majcherek

Polish Centre of Mediterranean Archaeology, University of Warsaw

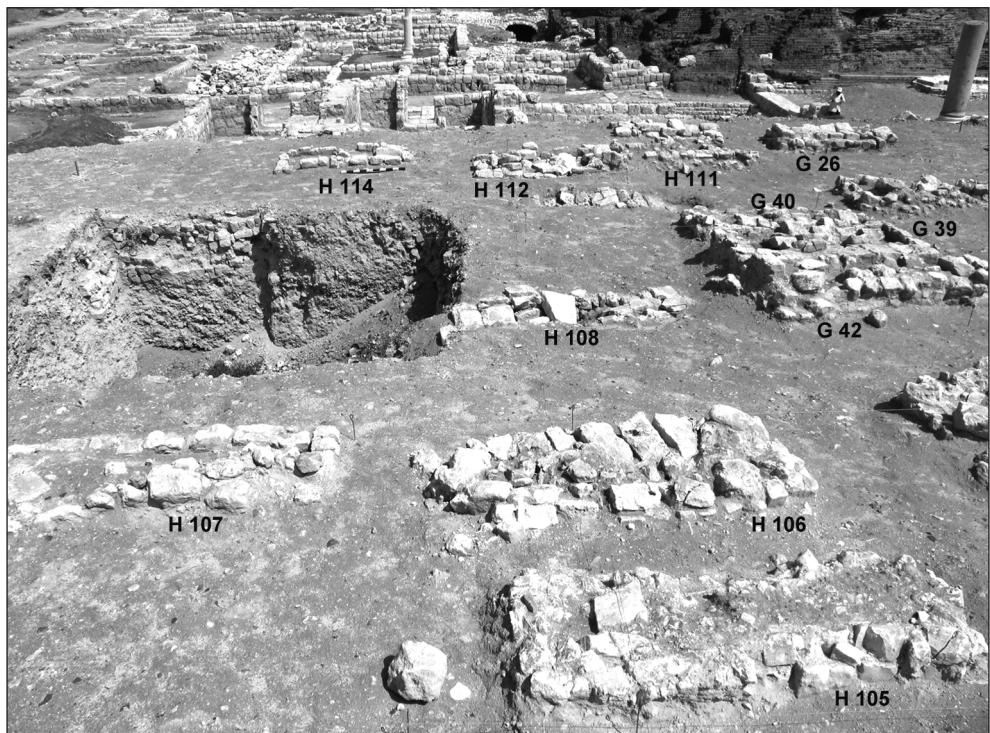
extent of the excavation trench, although showing no regular pattern [Fig. 1; for the plan, see Fig. 1 on page 55].

Fig. 1. General view of the excavated Islamic burial ground in Area H, looking north
(Photo G. Majcherek)

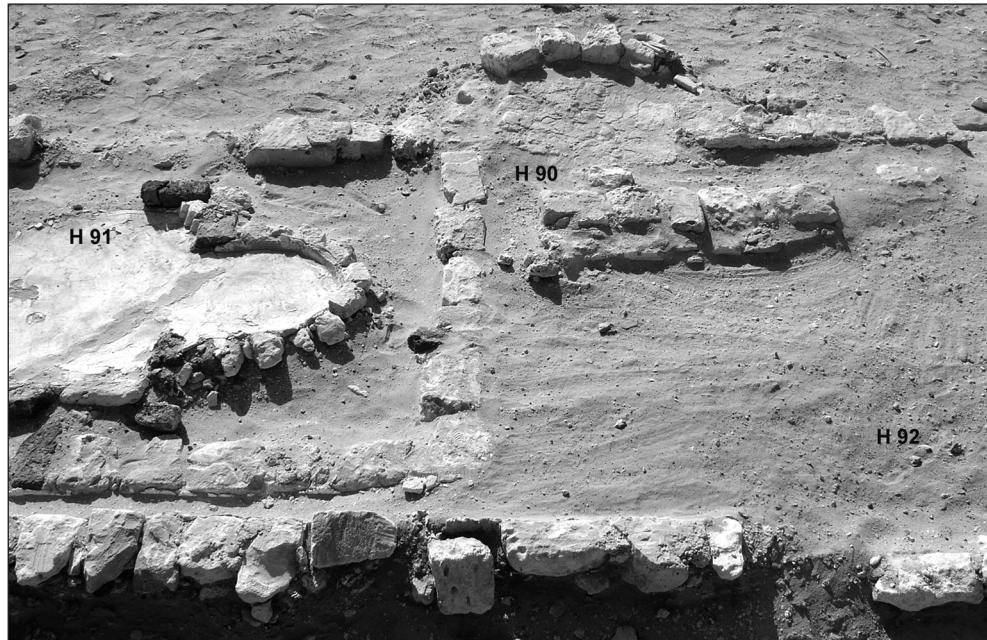
H 93 and H 91, the latter still retaining some of its original plasterwork [Fig. 2; see also Fig. 2, right, on page 56], were found to be enclosed together with H 90 within a rectangular stone wall enclosure, of which only the lower courses have been preserved. The enclosure, measuring some 5.50 x 4.80 m, was equipped with a small *mihrab* in the southeastern wall [see Fig. 3 on page 56]. Similar structures enclosing several neighboring graves, interpreted as family tombs, were previously recognized also in other areas of the cemetery (Majcherek, Kołataj 2003: 21).

Fig. 2. Grave H 91 and associated burials in Area H
 (Photo E. Kulicka)

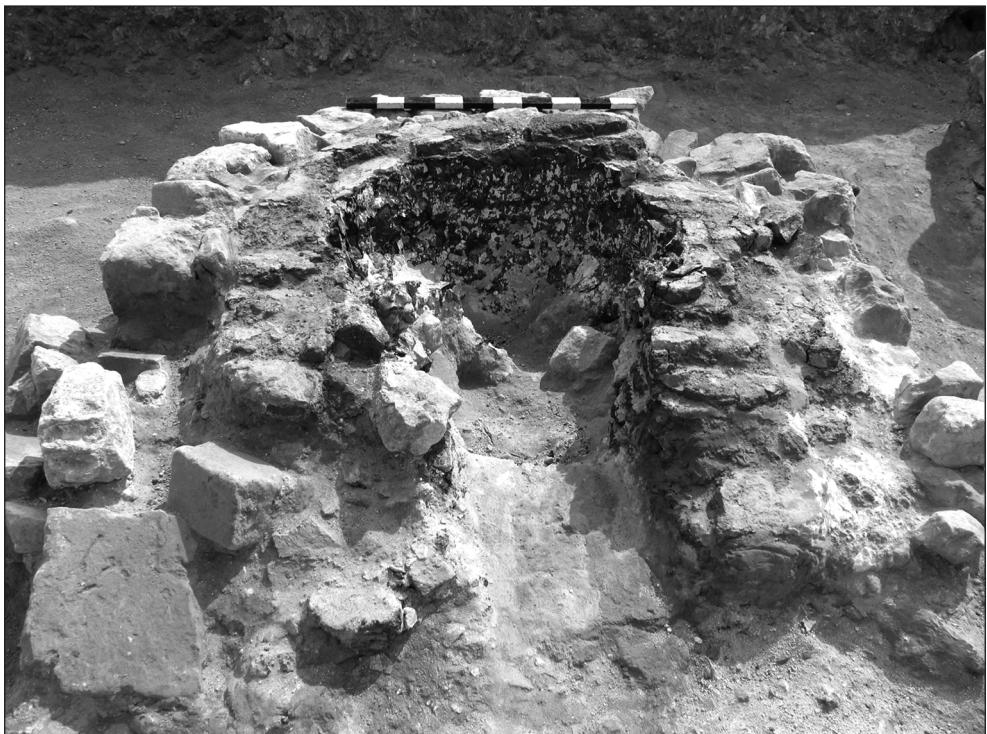
Fig. 5. Lime kiln in Area F, looking south
(Photo G. Majcherek)

cleared immediately below the thick ash accumulation in the southwestern corner of the trench. Despite heavy damage to the structure, both features could be recognized as round updraft kilns, approximately 1.00–1.10 m in diameter, built of red bricks bonded in clay mortar [Fig. 5]. The brick-made firing chambers were reinforced with semicircular casing walls of stone. Remnants of brick-made vaults were preserved on the outer lateral walls. The inner surface of the kilns was found to be partly vitrified due to high temperature. Between the kilns there was a fragmentarily preserved tank for slaking lime. Narrow, corridor-like features were cleared in front of the kilns; they were constructed of loosely arranged assorted stones, also making use of still standing walls of an Early Roman house in the layer below. They were used in all likelihood in the loading and firing operation,

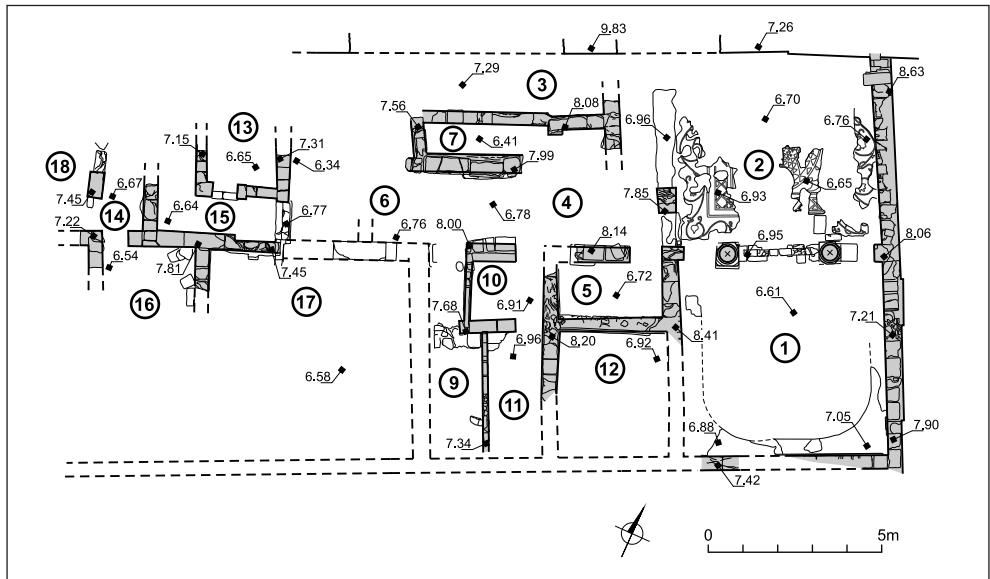
Fig. 7. Ground plan of Early Roman house FB in Area F
(A. Brzozowska, G. Karpińska)

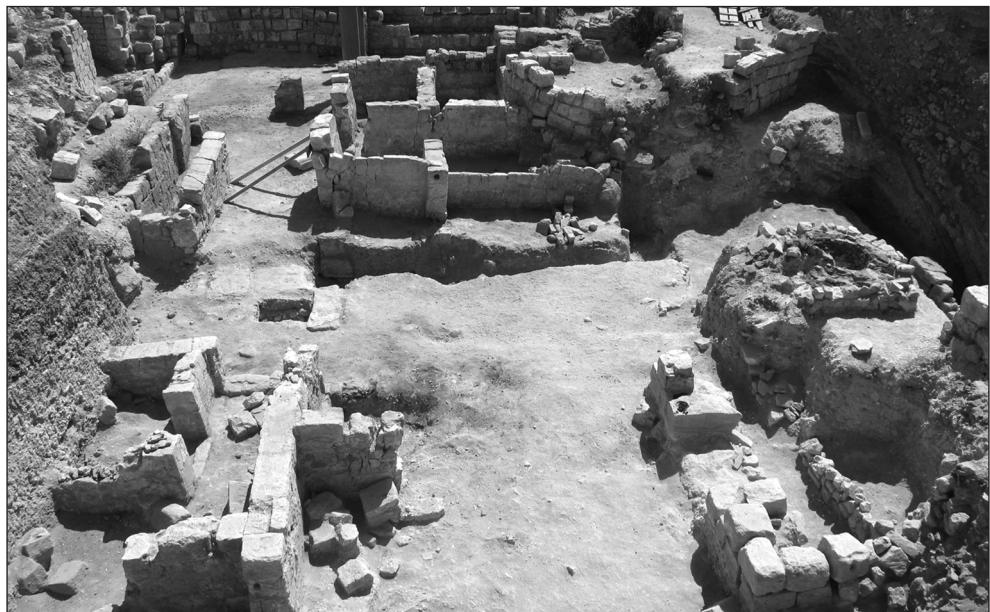
Fig. 8. General view of Early Roman house FB in Area F, looking east
(Photo G. Majcherek)

Room 12, partly excavated in 2007, was separated from the rest of the building and acted most probably as a shop with access from the street. A cluster of rooms excavated this season in the northwestern part of the trench (at bottom left in Fig. 8) were difficult to interpret, having been largely obscured or damaged by the large outer wall of the bath which cut through the ruins of the Early Roman house. Given their rather small dimensions, they should be expected to serve a purely domestic function. Locus 15 was apparently a corridor (about 1 m wide) giving access to another, as yet unexplored, section of the house. In partly preserved room 17 a large charcoal deposit was cleared, representing most probably a secondary phase of occupation when the house was already prob-

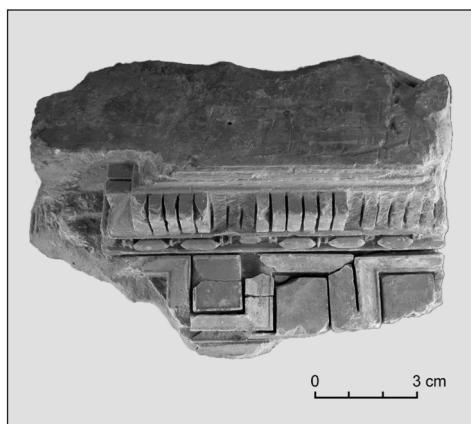
order, e.g. a section of cornice with alternating flat grooved and square hollowed modillions [Fig. 11]. This, as well as a fragment of a Doric frieze and fluted half-column found there point to a rather sumptuous architectural decoration of this, as yet unexplored, house.

Fig. 11. Cornice of the Alexandria Corinthian order (Photo G. Majcherek)

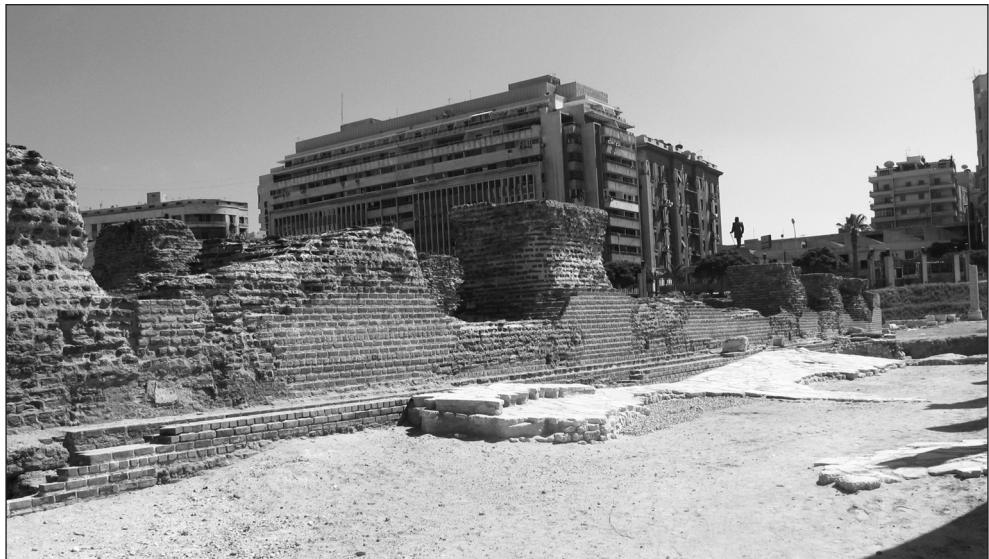
The restoration of the southern bath façade, which is an integral part of the planned open-air display of the ancient ruins, has now been completed (some 30 m in length), following two earlier seasons of work on the eastern end of the façade (Majcherek 2005: 27–29) [Fig. 12].

The wall structure had suffered serious erosion and deliberate damage in late antiquity and the medieval period. Some of the bricks were found to be completely deteriorated, while the mortar had lost all its cohesive strength. Given the complexity of the original bonding (at least two basic

Fig. 12. Restored southern façade of the bath
(Photo G. Majcherek)

brick sizes had been used), it was deemed necessary to prepare first the required number of modern bricks to be used in the conservation operation. This was achieved by cutting modern factory bricks to the required size. The mortar used during the process was based on an ancient Roman formula made of sand, lime and crushed bricks mixed in a ratio of 4:2:1. This helped not only in achieving proper quality, but also the desired coloring. The elevation was restored to a height of some 1.60 m, that is, the level of the original window sills. In several cases, extant lower courses of the masonry had to be reinforced with new

mortar, and some of the more seriously damaged bricks replaced with new ones, to make the wall facing structurally sound.

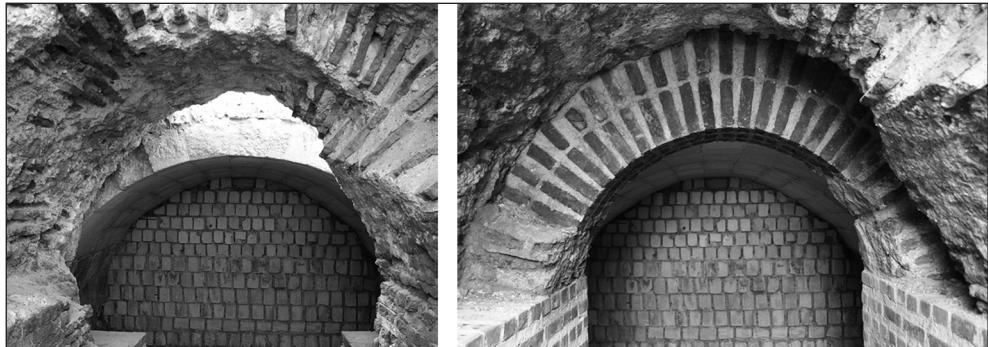
Fig. 13. One of the restored vaults giving access to the furnaces in the baths, before (left) and after restoration (Photo A. Pisarzewski)

Preservation of the southern elevation required also the restoration of two brick-made vaults, giving access to the furnaces located in the basement of the baths. Extant sections of the vaults were first consolidated. Existing void joints were filled in and some loose bricks were fixed with new mortar. For the full restoration original bricks found during excavations were used. Two such vaults, supporting the elevation, were entirely restored [Fig. 13]. Two additional, partially preserved furnace vaults were also consolidated.

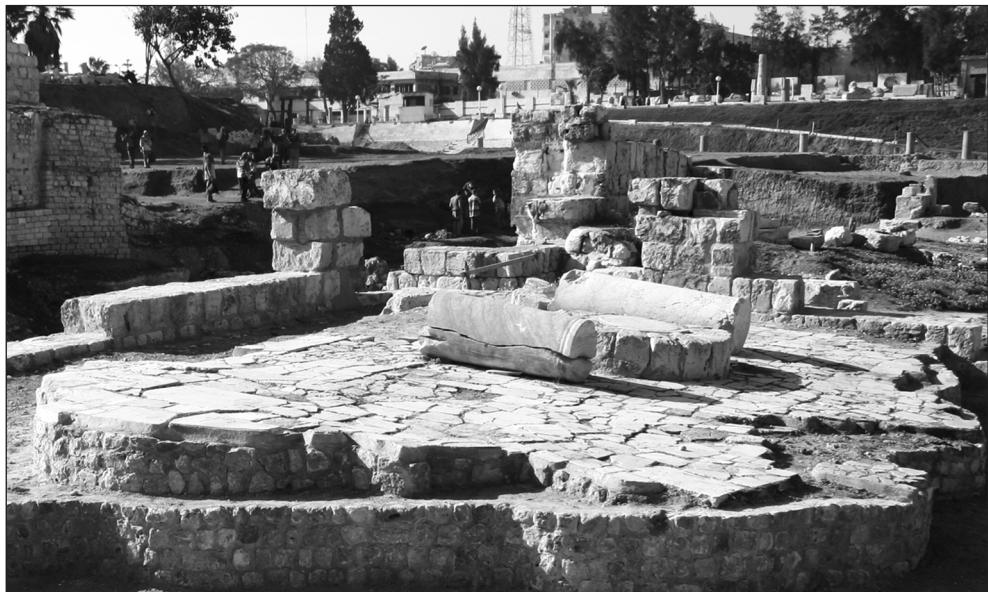
Fig. 14. Bath apodyterium following restoration in 2008, looking southwest (Photo G. Majcherek)

The nearby apodyterium also underwent thorough conservation. The extant floor pavement was consolidated. Some slabs were fixed with mortar and others re-laid on new bedding. Since the floor now rests

some 0.60–0.80 m above surrounding ground, the edges of the pavement had to be supported and protected with a low retaining wall to prevent subsiding and disintegration [Fig. 14]. The wall was built of small assorted stones, in a manner similar to the original bedding.

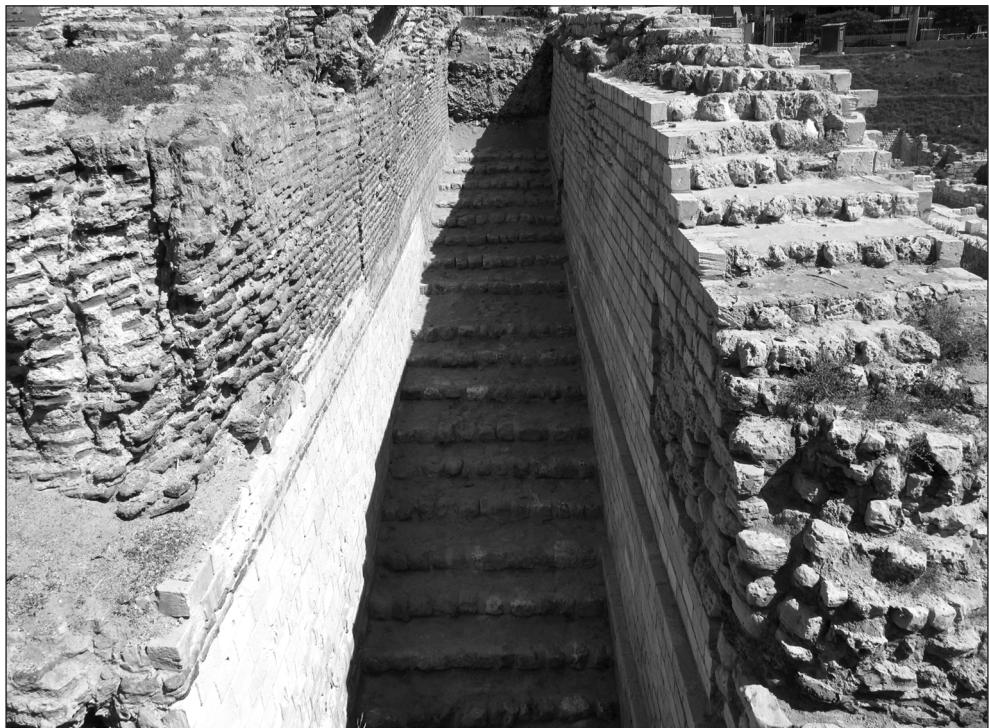
Fig. 15. Restored staircase in the cistern building, looking north
(Photo G. Majcherek)

up to the level of the top of the water tanks, served most probably as a ramp for bringing up animals to run the water-lifting *saqiyah* devices. The stairs were found to be either destroyed or dismantled along the edges, next to the walls of the corridor where most of the medieval robbing activity had occurred. The stairs were repaired and consolidated [Fig. 15].
