ALEXANDRIA

EXCAVATIONS AND PRESERVATION WORK ON KOM EL-DIKKA, PRELIMINARY REPORT 2009/2010

Grzegorz Majcherek

Polish Centre of Mediterranean Archaeology, University of Warsaw

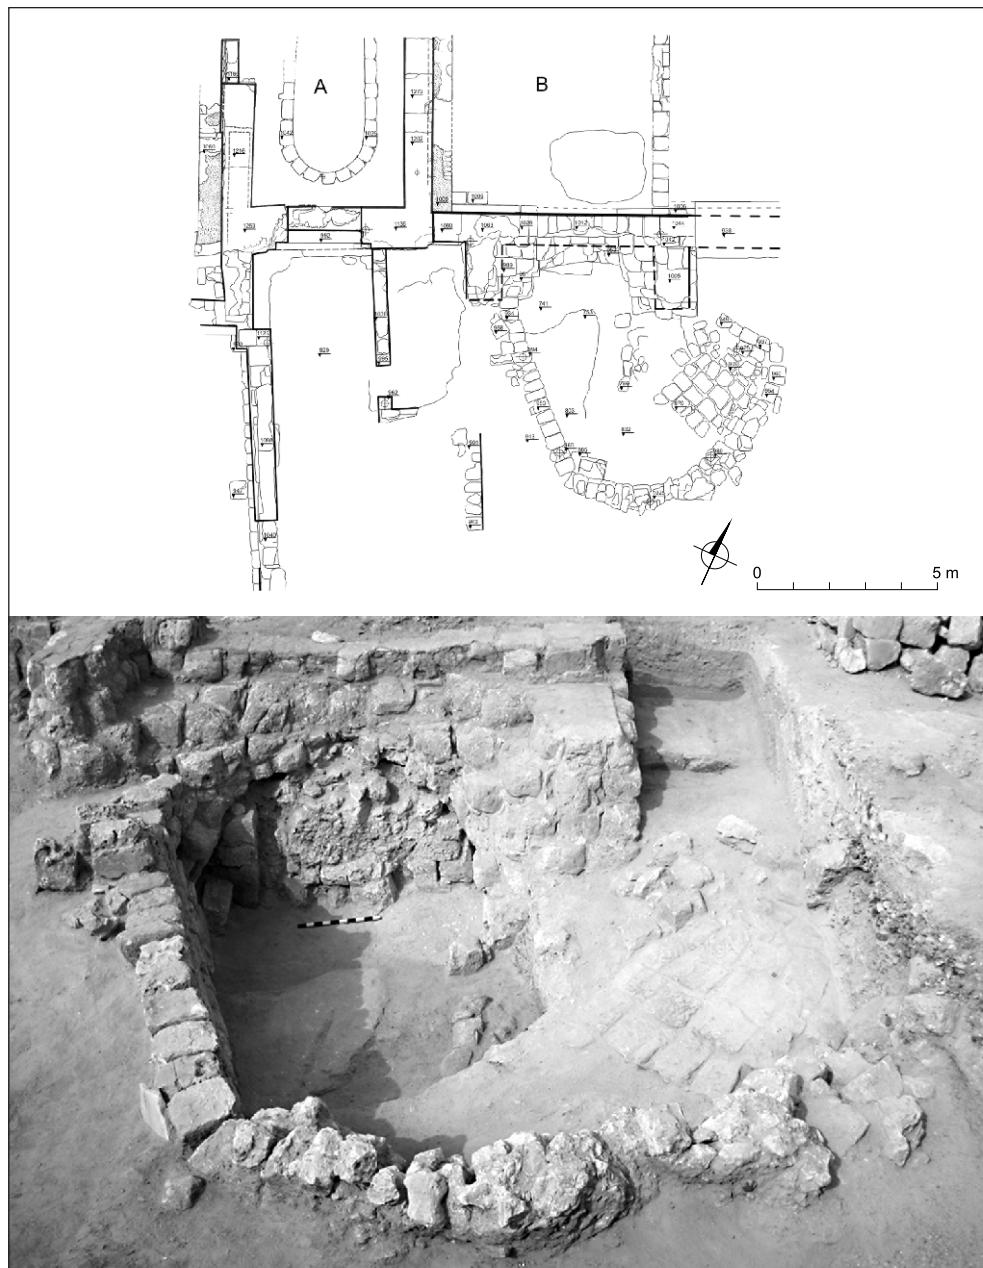
Fig. 3. Western entrance to the basement of the bath: localization plan (top) and view looking north including the ramp (Drawing K. Kamiński, J. Dobrowolski, updated 2010 G. Karpińska; photo E. Kulicka)

The western entrance occupied almost the whole width (approx. 3.05 m) of the underground chamber located directly below auditorium B [Fig. 3]. Previous exploration in this area had shown that the floor level of auditorium B is now substantially lower due to caving in of the original vaulting underneath. The collapse

Preliminary analysis of the structure indicated that the vaulting was constructed together with the huge southern perimeter wall of the bathhouse and should thus be considered part of the original design. The entrance was found to be flanked by two massive, now heavily weathered, buttresses. Both buttresses, some 1.60 m wide, were built in a technique similar to that employed in the construction of buttresses discovered further to the east (area F). A floor level was cleared some 1.70 m below the preserved keystone (the vault is now substantially disintegrated). Made of battered ashes and tamped soil reinforced with lime mortar, the floor attained extraordinary hardness. The most unusual feature, however, was uncovered in front of the entrance. It was a wide, sloping ramp, turning slightly to the left (i.e., to the east) and leading up to the south portico of the bath. While the section next to the entryway had only a tamped-soil floor, the midsection was reinforced with large limestone pavers, and in the top section (on near-ground level) several stone-made steps were cleared [Fig. 3, top]. The chronological and stratigraphical context of the ramp is yet to be resolved. While it appears that the entrance itself was part of the bath's original design, it is obvious that the sloping ramp is of a substantially later date. Even taking into consideration the apparent subsiding of the vault, the cleared floor is definitely too high (approximately 1.70 m below the preserved keystone) to be original. Secondly, its side walls, made of reused large blocks, were placed against a thick stratum of accumulated ashes. Two small lateral pillars, reducing the original width of the

entrance, rest on the tamped floor and were therefore a later addition. The general direction of the ramp implies the presence of an additional door in the perimeter wall, next to auditorium B. To conclude, the ramp must have been formed following the transformation of nearby halls A and C into auditoria (late 5th–early 6th century AD); its construction cancelled out the original access to the bath basement. On the other hand, it is quite obvious that the original floor level of the basement could be found underneath.

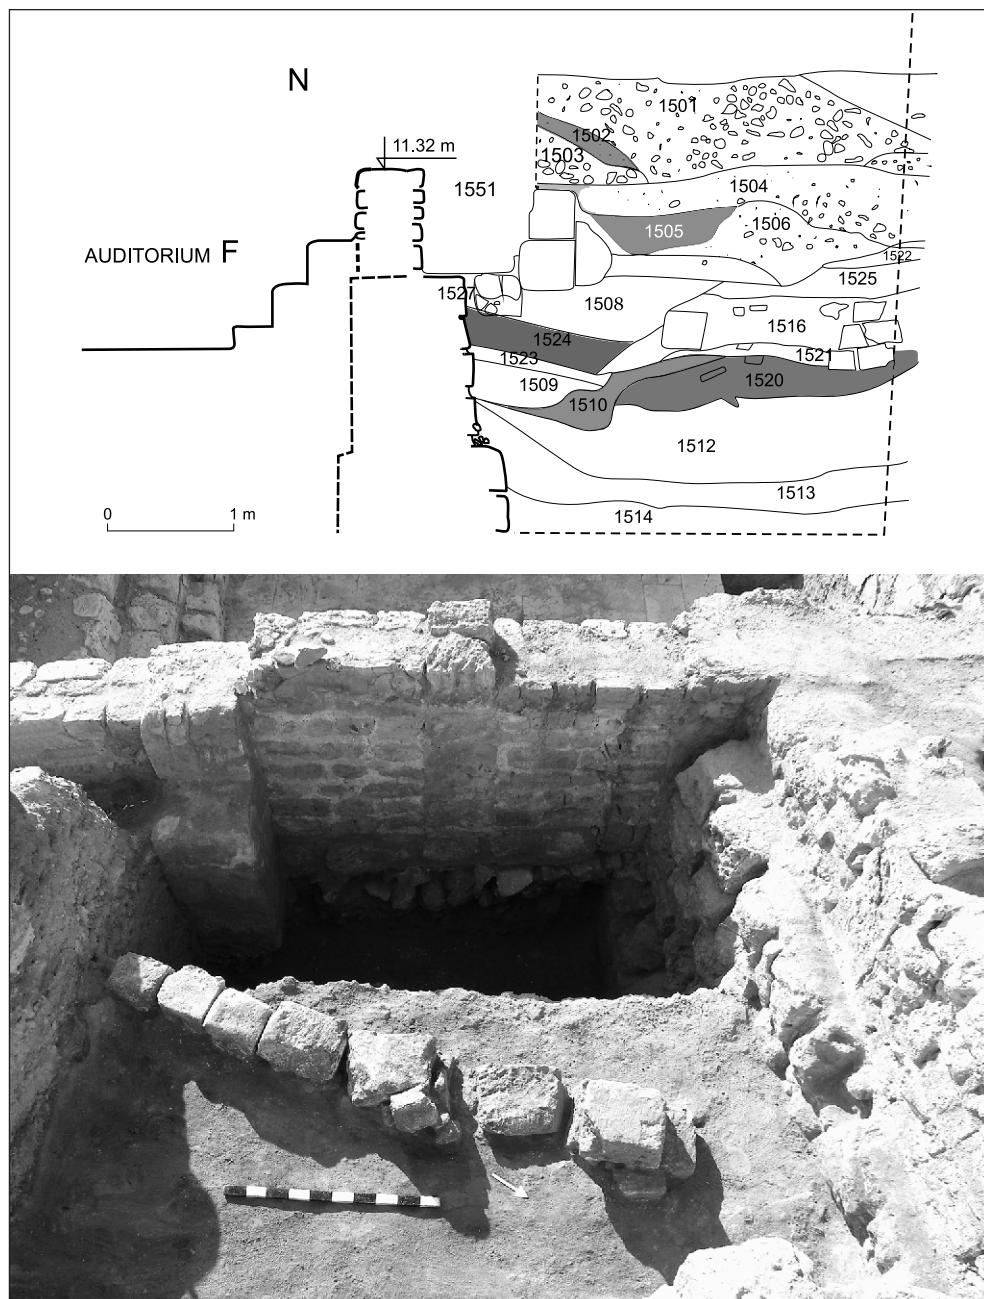
Fig. 6. Trench H-east. Section, east trench wall (top); view of east wall of auditorium H from the west (Drawing K. Lach, A. Smilgin; photo L. Wojnarowicz)

The other trench, H-east, dug in the corner formed by auditoria F and H, produced similar stratigraphical and chronological results. The east wall of auditorium H (structured in the pillar technique) was built in a deep trench, cutting through the thick deposits of urban refuse and ashes [Fig. 6, bottom]. Finds from layers predating the cut pointed to a rather surprisingly late date (6th century AD) for the construction of the wall [Fig. 6, top]. This may seem to collide with earlier findings concerning other auditoria and calls for a substantial chronological reappraisal. However, the footing of the wall foundation was placed level with the floor in auditorium H and as such could not have been part of the original design, but rather a later rebuilding or adaptation. The south wall of auditorium F, structured in the typical pillar technique, was also built on top of a huge, earlier construction. Although found in a very deep trench, its surface appeared to be heavily weathered — clear evidence of prolonged exposure. This heavily buttressed wall, made of large ashlars, shares the technique, mortar type, size of ashlars and other features with other structures of apparently earlier date preserved in the vicinity, such as the walls dividing auditoria F and G, and auditoria A and B, as well as the huge perimeter wall at the southern limit of the bath complex

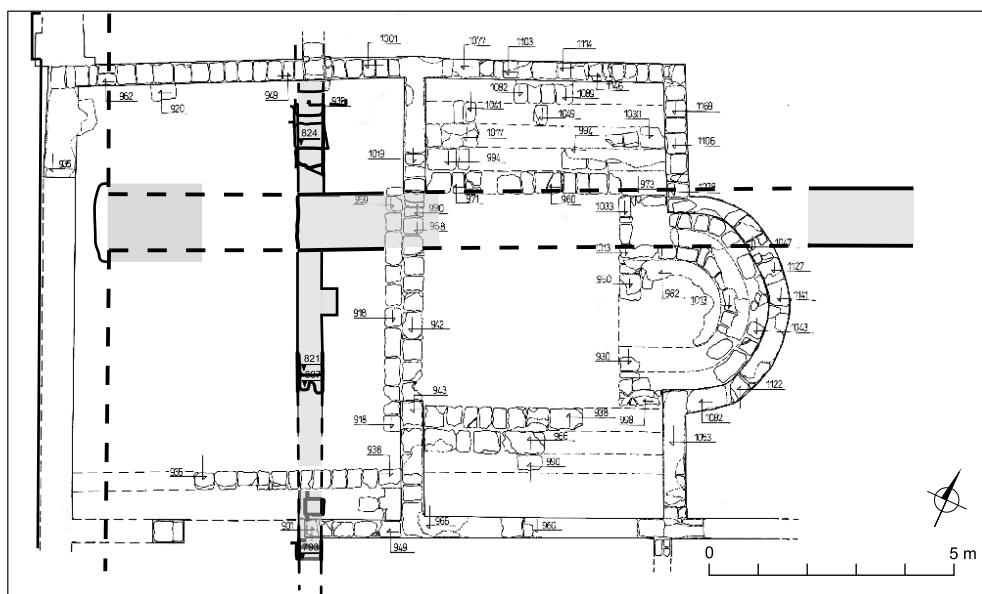
Fig. 8. Structures predating auditorium OP marked in gray
(Drawing K. Błaszczyk, G. Karpińska, G. Majcherek)

Foundations were built of large ashlar (approximately 0.50–0.60 m in length), set in lime mortar. That our wall was a later addition to the overall design is clearly evidenced by a deep cut preserved on the eastern face of the portico’s back wall [Fig. 9]. The cut was apparently made to anchor the later wall to the structure of the portico. The purpose of this wall remained unclear, but it may have been a leftover from some unknown urban design that was abandoned and subsequently demolished in the 5th century AD. Two more sections of the same wall were discovered previously in deep trenches, further east of this auditorium (Rodziewicz 1991).

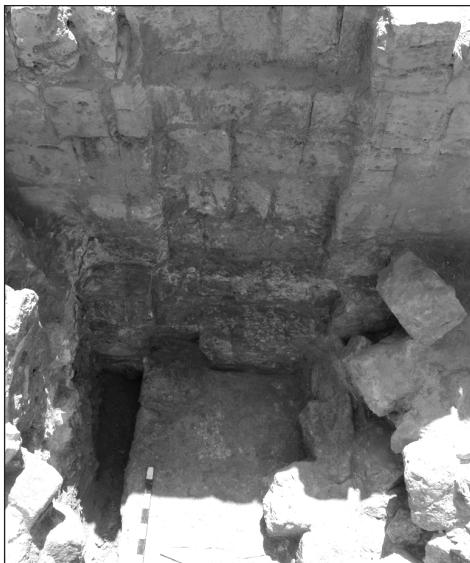
Fig. 9. Abutment of the east-west wall and the portico back wall (Photo A. Smilgin)

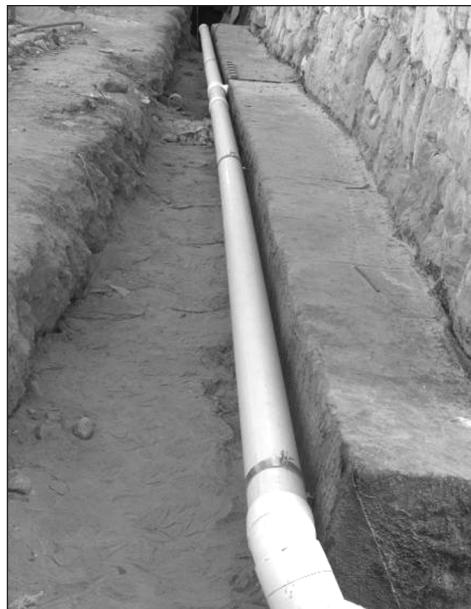
Fig. 10. Consolidated foundations and rainwater drainage of the east wall of the mosaic shelter (Photo J. Brochocki)

The foundations of the east wall of the shelter, which made use of a Late Roman wall, were cleared down to the footing

along the entire length of the wall (approximately 16 m). The deteriorated wall structure was repaired, missing or deteriorated blocks being replaced with new ones and the whole foundation consolidated with new mortar. The top and side surfaces of the foundations were rendered and waterproofed with pitch coating [Fig. 10]. Additional waterproof coating of double-folded polyethylene insulation sheets was applied for more effective anti-damp protection. To prevent further water penetration, the wall coping was consolidated and reshaped with a slight fall towards the outside.

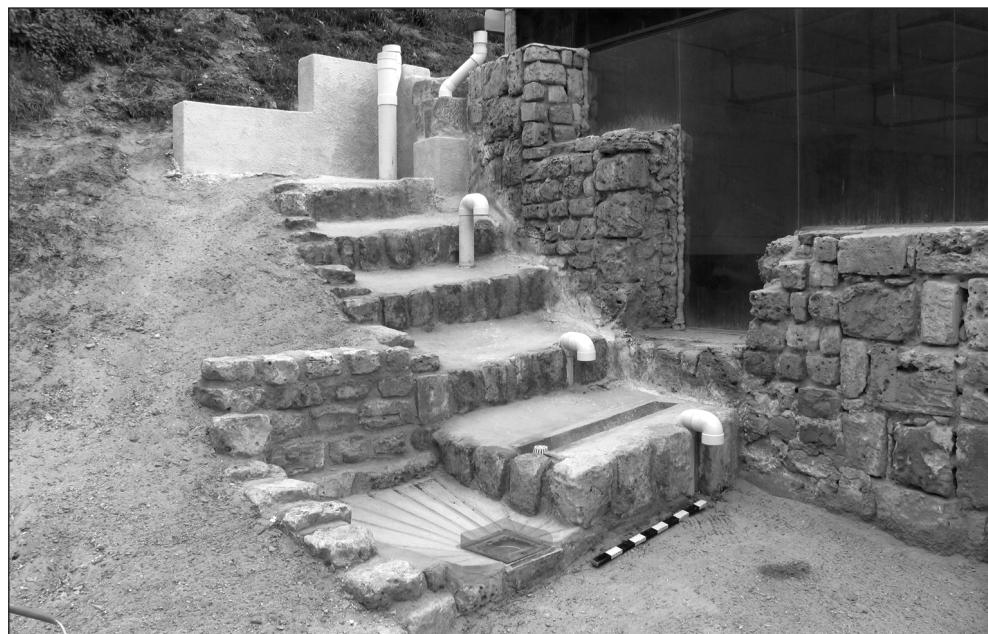
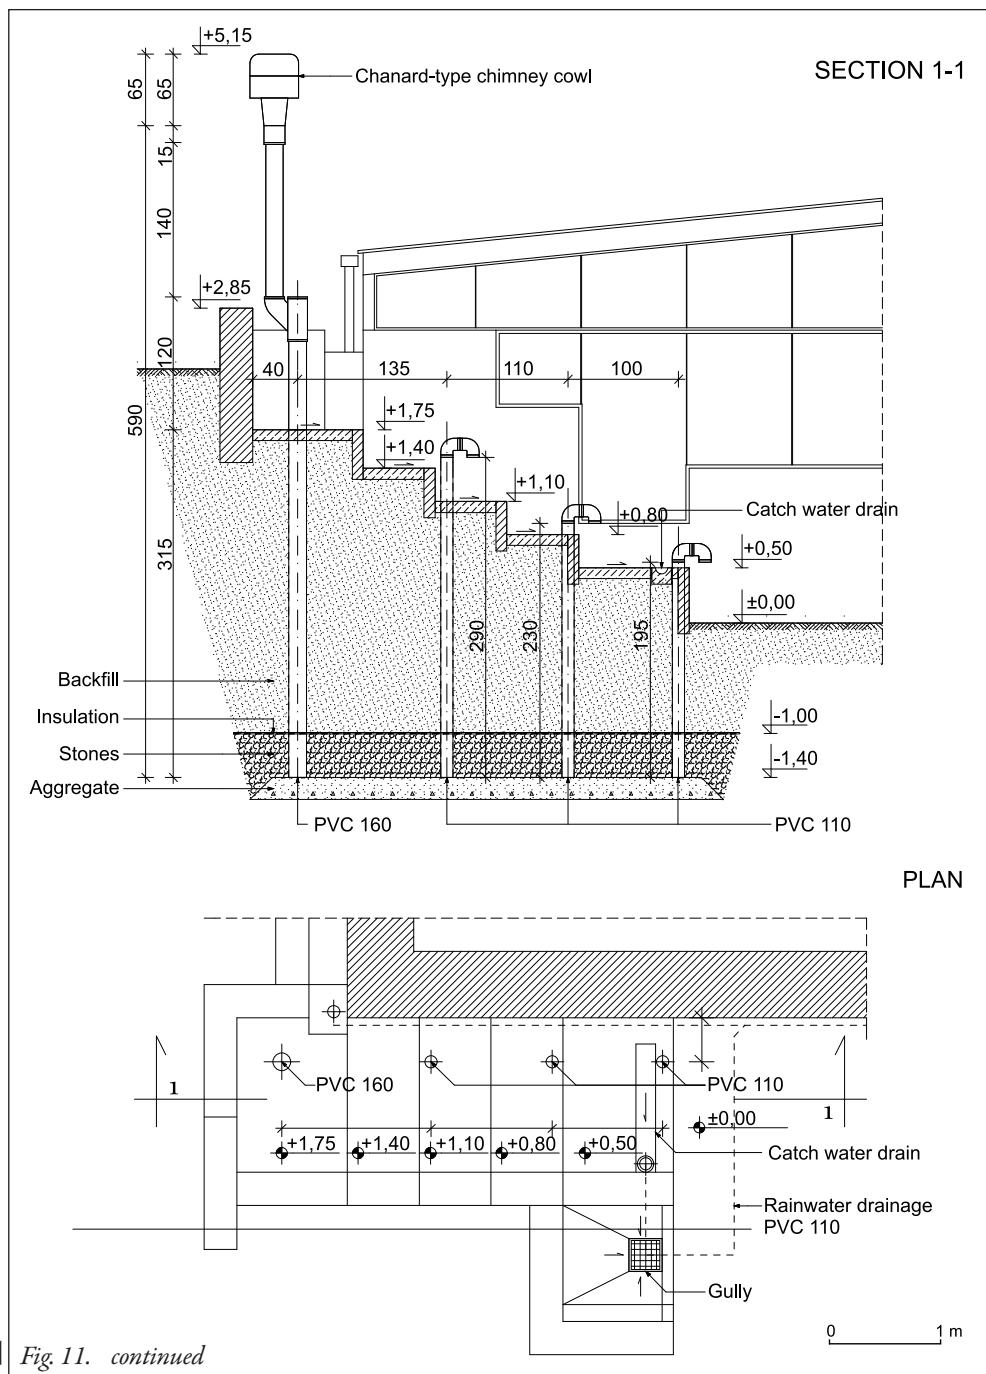
Fig. 11. Redesigned drainage system, plan and section (opposite page) and view of the southeastern corner of the shelter with the new drainage in place (top) (Drawing Z. Nawrot, M. Polak; photo G. Majcherek)

The faulty rainwater disposal system was redesigned to collect rainwater from both roof slopes and to drain it off to a nearby ancient well [Fig. 11]. The gutters were either remodeled or new ones, shaped of squared sheet iron, introduced along the eaves of the roof. New downspouts (PVC Ø 100 mm) were installed at the eastern ends of both gutters. The downpipes discharged into the main drain (PVC Ø 100 mm) buried along the east wall, emptying into an ancient well located north of the shelter. The installation took into account Alexandrian climate, being designed to cope with frequent copious winter downpours.

An additional drying installation was introduced in the southeastern corner of the shelter, which is the part of the structure that is the most liable to water seepage and hence most endangered [see Fig. 11]. As in other locations along the eastern elevation, the foundations were first consolidated and pitched. Then, the trench was filled with aggregate and gravel. Ventilation shafts of PVC pipes of varying length, corresponding to the rise of the ground, were installed vertically at 1.00–1.30 m intervals. The largest shaft (PVC Ø 150 mm, 5.15 m long) was positioned in the corner and was topped with a turbovent-rotary chimney cowl (Chanard-type). Considerable differences of atmospheric pressure have made the installation extremely effective in removing damp from the lowermost part of the foundations.

The adjacent section of the escarpment was reshaped into a series of cascading terraces designed to slow down slope erosion and minimize water infiltration. A side drain leading to a gully was installed by the lowermost terrace. The gully was then connected with the main PVC drain running along the east wall.

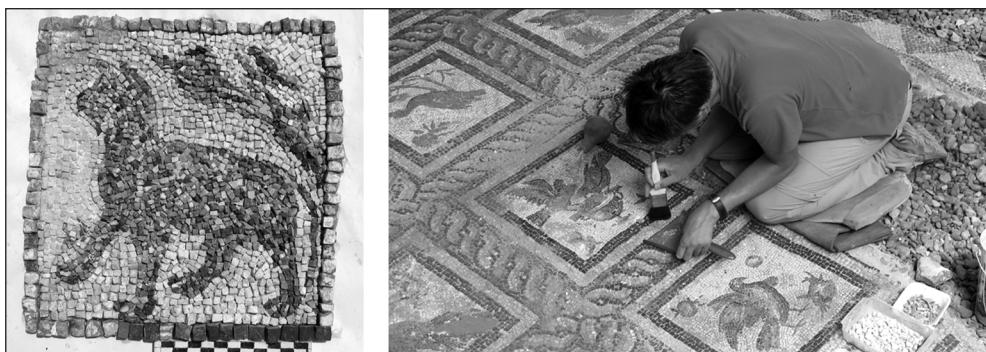
Fig. 12. Conservation of mosaics: detached emblema during conservation (left) and work on the mosaic floor (Photos G. Majcherek)

The mosaics were likewise consolidated. Conservation *in situ* carried out in the late 1990s in accordance with the premises of the Villa of the Birds Conservation Project had not anticipated certain problems. The draining system installed at the time proved insufficient to secure a stable environment; seasonal and daily variations of temperature and humidity caused salt precipitation and rapid deterioration of the multi-colored tesserae (both marble and glass ones) and lime mortar bedding. Two of the most endangered mosaics were treated this season. The central emblema (21 cm by 22 cm) of mosaic α-6 ("Panther mosaic") was detached and consolidated [Fig. 12, left]; some disintegrated glass and faience tesserae were removed and replaced with new ones. Losses were likewise completed with ancient cubes retrieved during excavations. A new layer of limestone mortar with ground marble filler and acrylic resin PLEXTOL B 500 was applied on the backing. The emblema was

then relaid on an aluminium honeycomb panel (2.5 cm thick), the support fixed with ARAldITE and reinstated. Mosaic α -5 ("Mosaic with Birds") was treated likewise [Fig. 12, right]. The surface was thoroughly cleaned and salt efflorescence removed mechanically. Some loose tesserae were fixed, decayed lime mortar and voids under the tesserae treated by injecting new mortar and the edges of the mosaic repaired. Mosaic α -3 (combining *opus tessellatum* and *opus sectile* techniques) was also secured. Its surface was cleaned and damaged sections of edges fixed. Conservation of the mosaics will be continued next season.

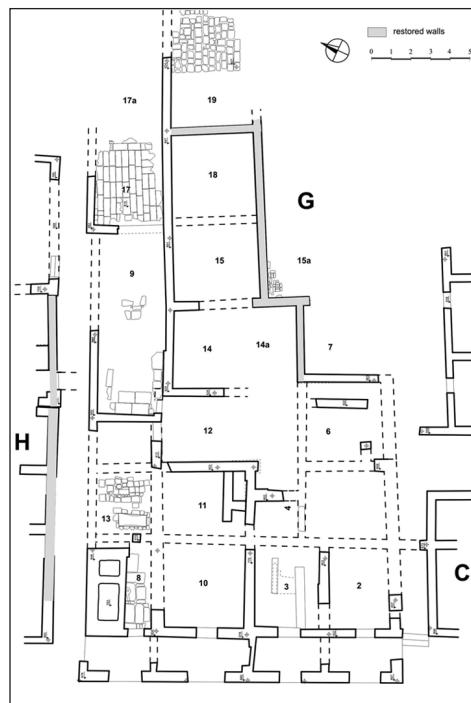
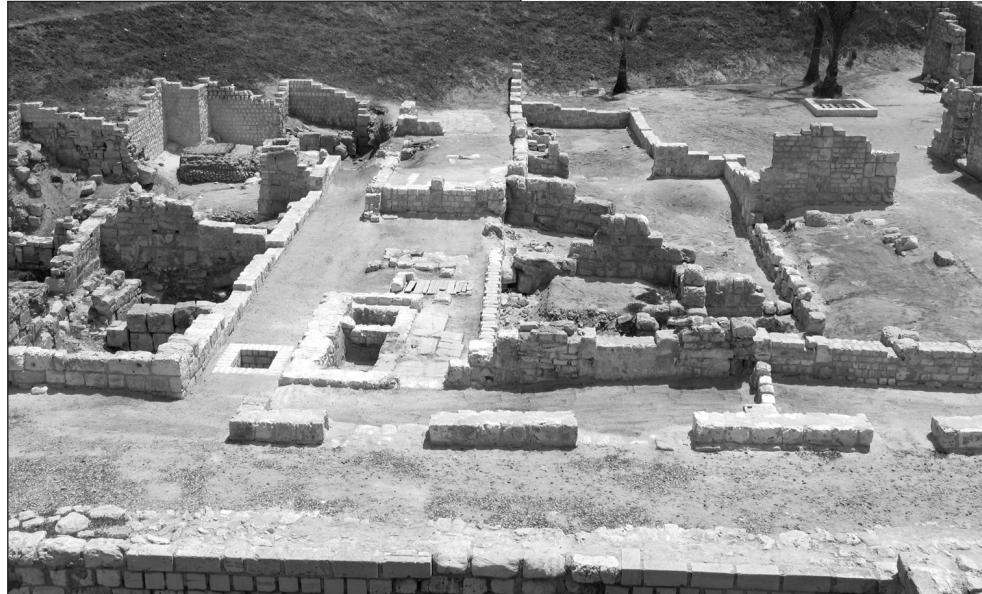
Fig. 13. Houses G and H, following wall restoration in 2010, looking east; top, plan of the area, restored walls marked in gray (Drawing K. Karpińska; photo G. Majcherek)

The south and east walls of room G18 were restored (altogether a stretch of 9.5 m) and the south walls of rooms G15 and G14a were also rebuilt. The restoration stopped one course above ground level as the excavation did not record the location of doors [Fig. 13, far back]. Most of the original walls (as evidenced by the extant sections) were structured in the pillar technique with a large block made of pillars set at regular intervals and the space between them filled with smaller assorted stones. In building H conservation was limited to the consolidation and partial restoration of the southern elevation [Fig. 13, top]. A large section of the wall (approximately 14 m long, 0.45–0.50 m thick) enclosing the southern wing of house H was restored to a height of approximately 1.10–1.30 m. Here the wall was structured in regular masonry with large ashlars set in isodomic courses. The restored wall courses were separated from the original masonry with a layer of bitumen tar paper, acting as both

anti-damp insulation and a recognizable border between the original fabric and modern additions. Ancient blocks found during excavations were used for the reconstruction in accordance with procedures previously established at the site (properly seasoned modern stone was not available).

A narrow east–west lane (perpendicular to street R4) dividing houses G and H was re-arranged to prepare the area for public display [see Fig. 13]. The operation included backfilling of some post-excavation trenches and surface leveling. A city sewer of Late Roman date running along the lane was also subjected to limited conservation. Several sections along the southern elevation of house H were consolidated and a manhole giving access to the sewer was partly restored. The manhole coping was rebuilt and made flush with the street level to secure safe traffic for visitors.

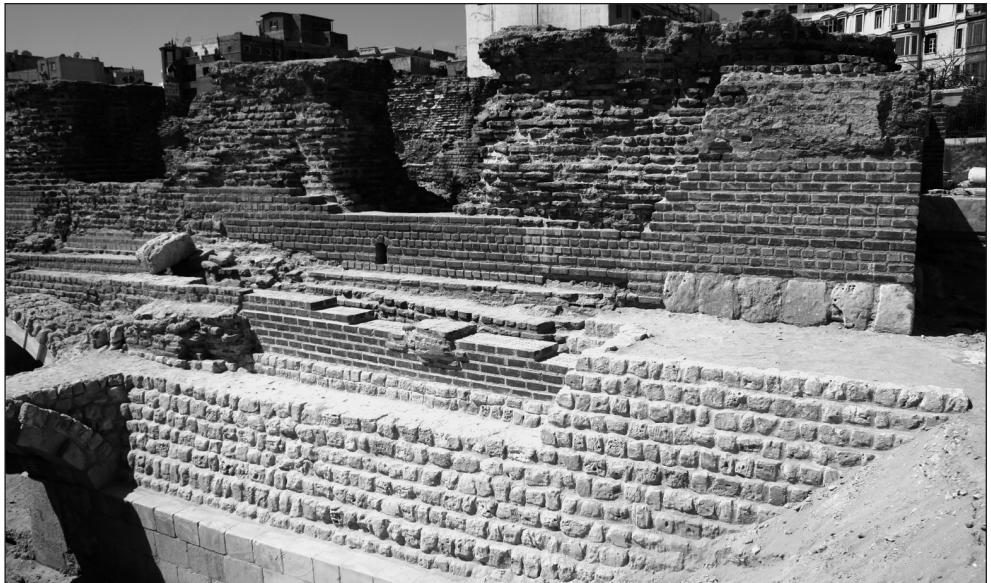
Fig. 14. Restored channel in the southeastern corner of the bath
(Photo A. Pisarzewski)

In the bath area, a modern stairway down into the cellar continued to be constructed; three steps were done out of the planned seven. A fragment of a channel running along the southern elevation of the bath was restored instead [Fig. 14]. The channel was originally designed to drain waste water from tubs and basins located there. Built of red bricks, it was lined with waterproof mortar and covered with unusually large limestone blocks. The channel was sunk in a pavement of assorted fragmentary slabs of marble and nummulitic limestone. Conservation procedures involved not only consolidation and partial restoration, but also re-integration of some loose wall fragments found *sub situ*.

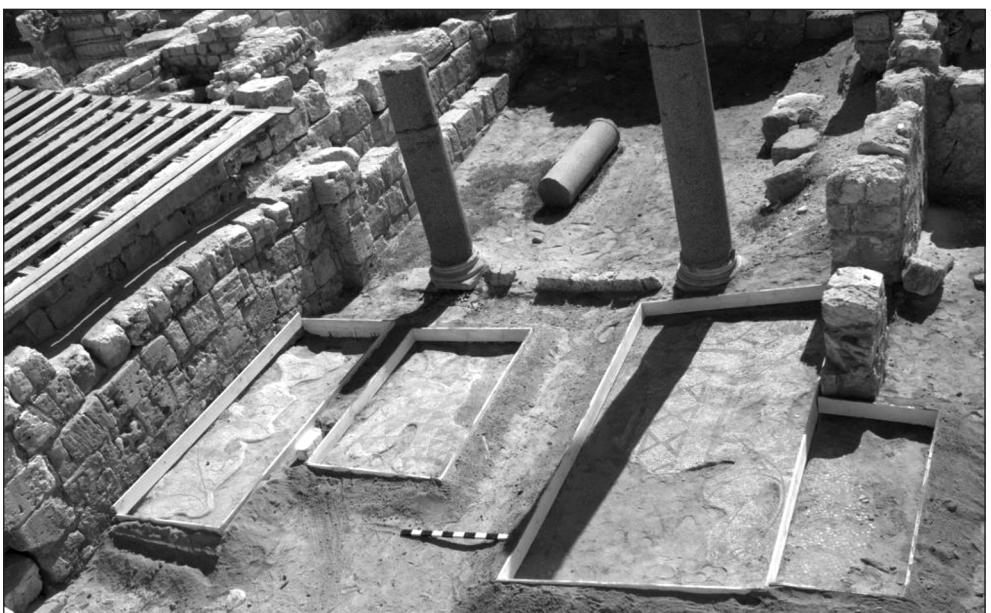
Fig. 15. Mosaics protected in area F (House FB)
(Photo R. Mahler)

Current maintenance preservation included, as usual, multiple locations and issues, ranging from basic procedures applied to wall fabric (tapping and grouting) to more elaborate ones, like stone replacement and shaping the wall coping. Measures were also taken to protect a fragmentary black-and-white mosaic with a geometric design discovered in house FB (Majcherek 1999), which was threatened by continuous heavy rains and vegetation. To preserve the integrity of the mosaic and to shield it from rainwater, the mosaic was protected with a specially built wooden casing [Fig. 15] and covered with a thick (0.15–0.20 m) protective layer of clean sand.
